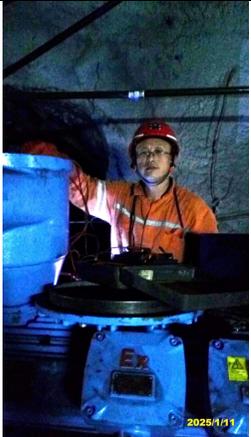
<p>2025/01/18</p>
66	GX-B1323/21-1-25001~25003	2025. 2. 26	本次共检煤矿交流电动机3台，3台煤矿交流电动机所检项目合格

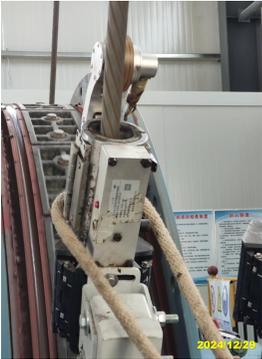
67	GX-B1598/24-1-25007	2025/2/27	实测钢丝绳有效截面积损失百分比最大为1.38%，小于5%为正常。

A close-up photograph of a mechanical testing device used for inspecting steel cables. The device is white and grey, with a thick, braided steel cable being processed. A date stamp in the bottom right corner reads "2024/12/29".
68	GX-B1598/24-1-25008	2025/2/27	实测钢丝绳有效截面积损失百分比最大为1.77%，小于5%为正常。

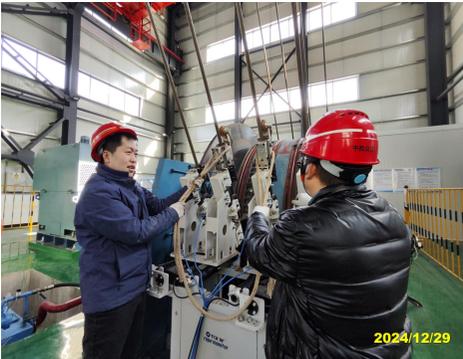
A photograph showing two workers in a large industrial facility. Both workers are wearing red hard hats and dark jackets. They are standing next to a large piece of machinery, likely the same testing device as in the first image, and appear to be conducting an inspection or adjustment. The background shows the interior of a factory with high ceilings and structural beams. A date stamp in the bottom right corner reads "2024/12/29".

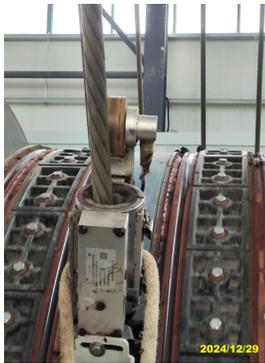
69	GX-B1598/24-1-25009	2025/2/27	实测钢丝绳有效截面积损失百分比最大为1.08%，小于5%为正常。

A photograph showing a close-up of a steel wire rope being processed by a machine. The rope is held in a metal fixture, and the machine's rollers and guides are visible. The background shows a factory setting with metal structures. A yellow timestamp '2024/12/29' is visible in the bottom right corner of the image.
70	GX-B1598/24-1-25010	2025/2/27	实测钢丝绳有效截面积损失百分比最大为1.79%，小于5%为正常。

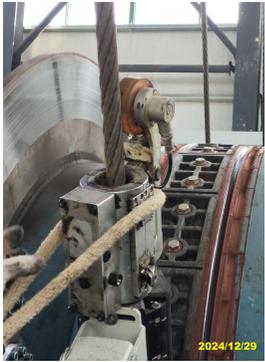
A photograph showing a close-up of a steel wire rope being processed by a machine. The rope is held in a metal fixture, and the machine's rollers and guides are visible. The background shows a factory setting with metal structures. A yellow timestamp '2024/12/29' is visible in the bottom right corner of the image.

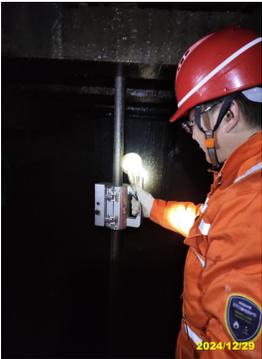
71	GX-B1598/24-1-25011	2025/2/27	实测钢丝绳有效截面积损失百分比最大为1.02%，小于10%为正常。

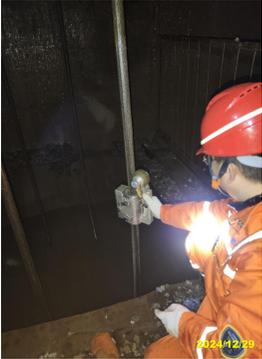
72	GX-B1598/24-1-25012	2025/2/27	实测钢丝绳有效截面积损失百分比最大为1.62%，小于10%为正常。

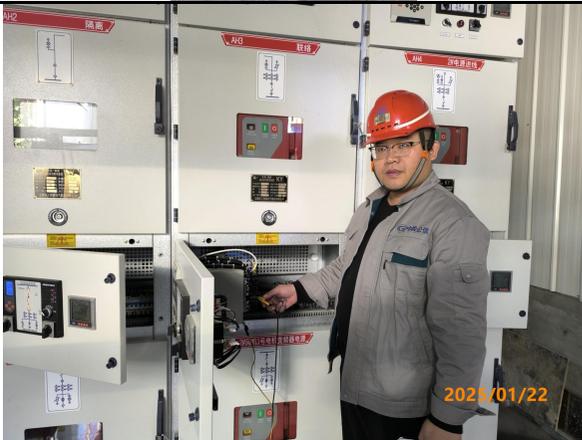
74	GX-B1495/20-1-25069~25086	2025. 2. 28	<p>本次共检高压开关设备18台，18台高压开关设备所检项目合格</p>
